# Inspection Report

**One Stop Inspections**

Report/Agreement # OSI78

This report Complies with Australian Building Standards AS 4349.1-2007. Inspection of Buildings Part 1: Pre- Purchase Inspections-Residential Buildings- Appendix "C and if applicable with AS 4349.3 (Visual Timber Pest Inspection Report)

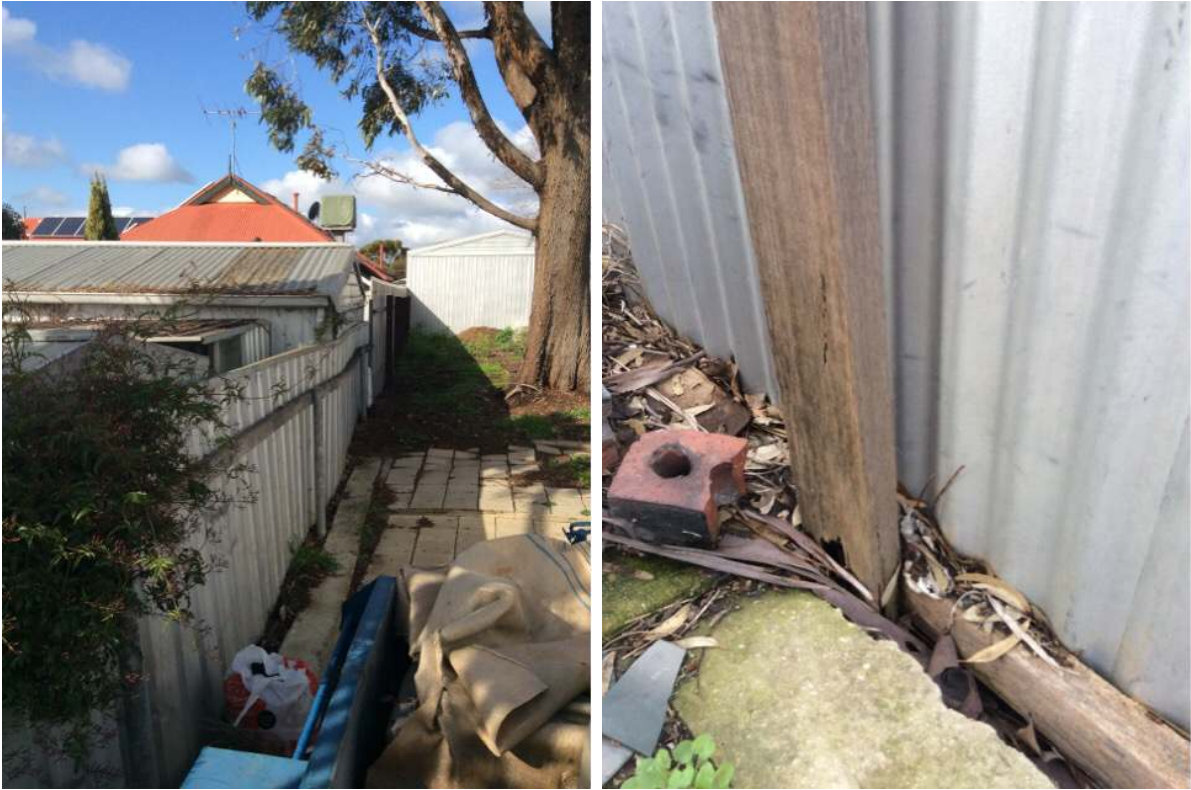
Of the visible areas, the general condition of the fences and gates is acceptable or in reasonable condition for age of dwelling.

General age to fence components - Recommendations: General upkeep/maintenance recommended. A qualified fencing contractor should be engaged for advice and recommendations.

Minor post base timber fungal decay - Recommendations: Repairs as required. It is preferable to have posts on stirrups kept out of contact with soil. Timber in contact with ground is conducive to termite infestation and timber fungal decay.

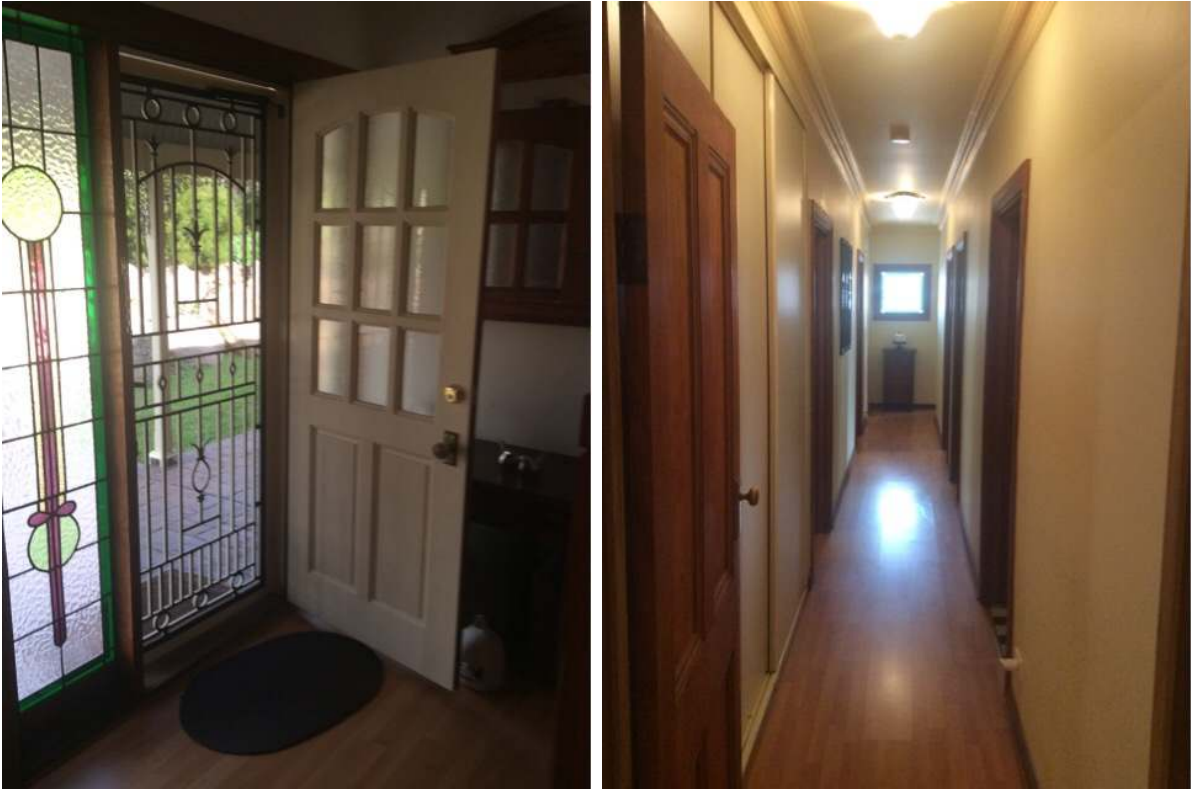
The hall is in acceptable condition with no notable structural defects

Hall door / frame deterioration - General age/damage has occurred to door frame, face or components. Recommendations: A qualified carpenter should be engaged for advice and recommendations.

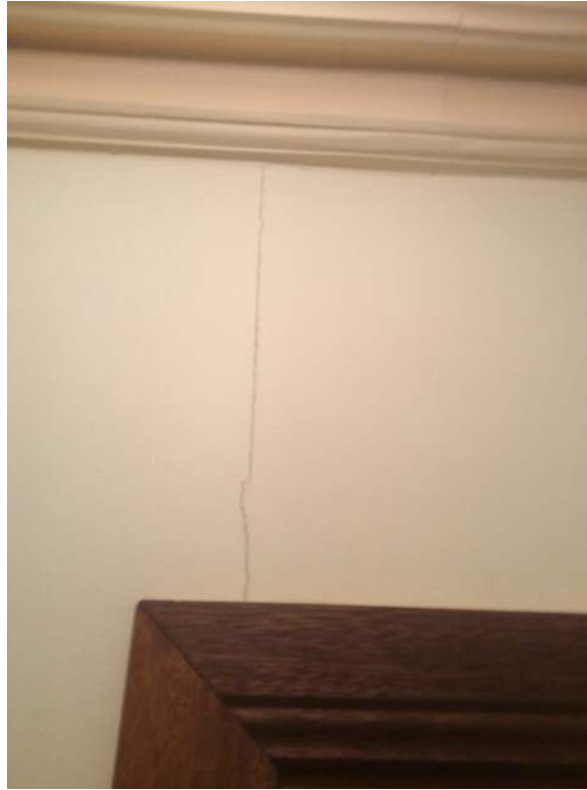
General ageing and/or denting and/or wear and/or previous wall patching and the like is evident on wall linings - Recommendations: A qualified painter should be engaged to assess and repair as required.

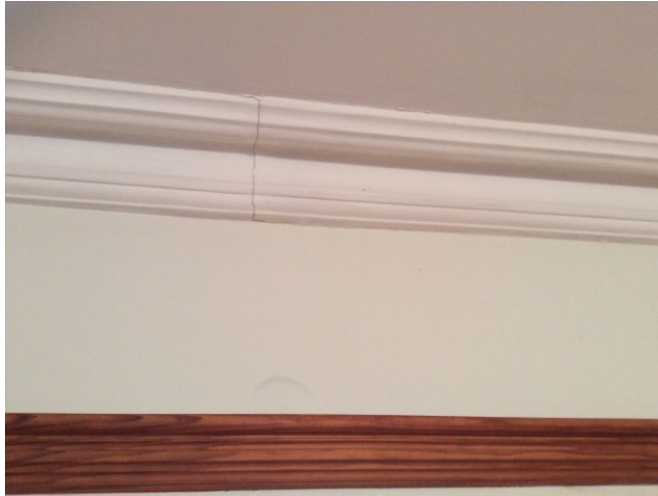
General ageing and/or denting and/or wear and/or previous patching and the like is evident on ceiling linings - Recommendations: A qualified painter and or plasterer should be engaged to assess and repair as required.

Settlement Cracks Noted . These are typical and generally patch and paint will suffice, however Monitoring these cracks advised for 12 months and if become wider or longer, you will need to contact a structural engineers to assess.

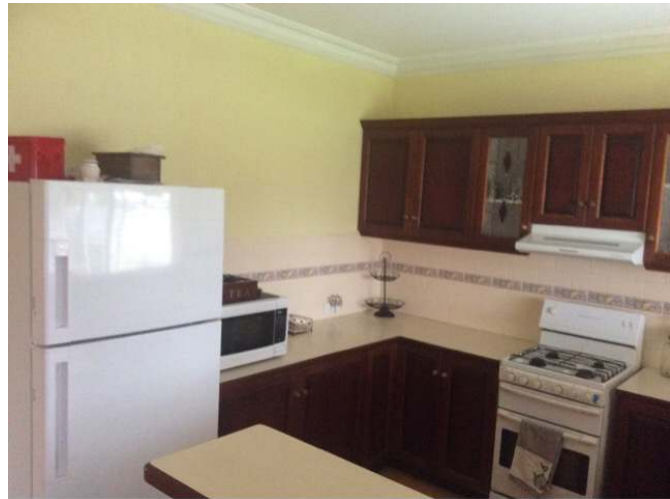
Minor ceiling lining cracks - Minor (hairline to 5mm) ceiling join cracks visible.  
Recommendations: I recommend you contact a licensed plasterer for further advice and recommendations.

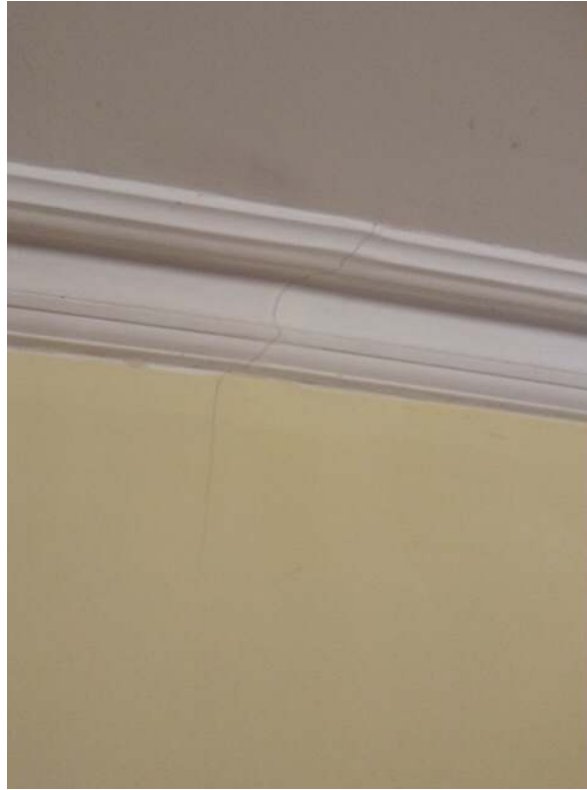
General ageing and/or denting and/or wear and/or previous wall patching and the like is evident on wall linings - Recommendations: A qualified painter should be engaged to assess and repair as required.

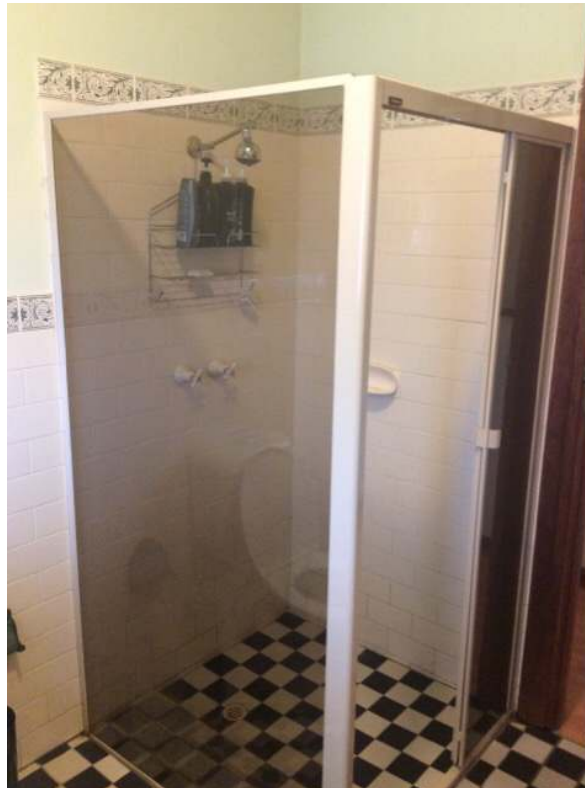
General ageing and/or denting and/or wear and/or previous wall patching and the like is evident on wall linings - Recommendations: A qualified painter should be engaged to assess and repair as required.

Moisture has been detected internally behind the taps or shower head. Suspected leaking bridge. Recommendations: Requires the attention off a qualified plumber.

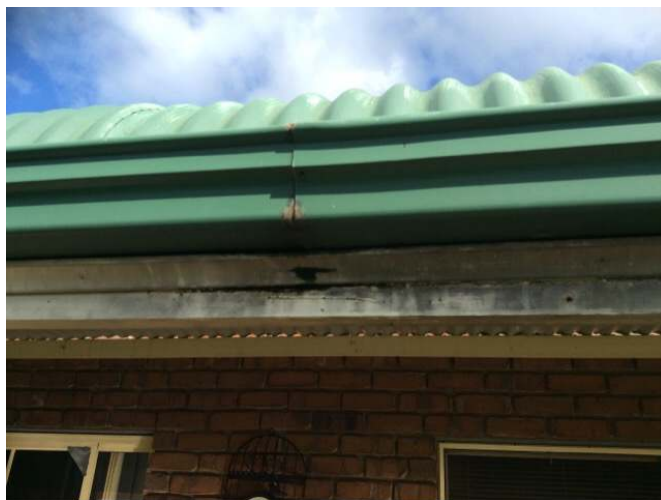
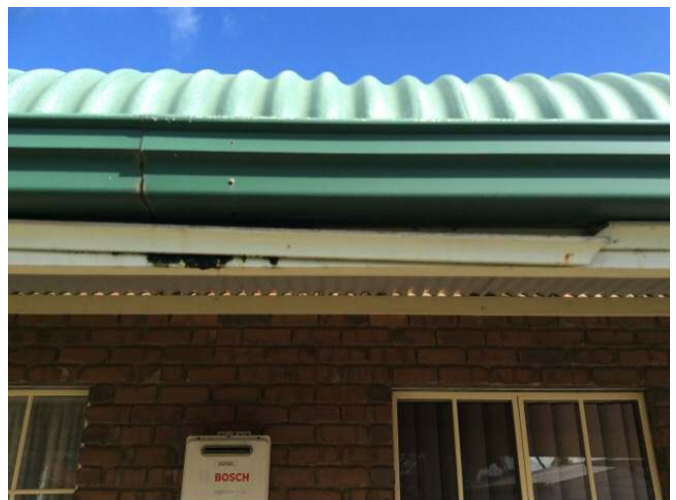
Timber fungal decay (rot) visible. Recommendations: A qualified carpenter should be engaged for advice and recommendations.

Separated on corner - Recommendations: A qualified carpenter should be engaged for advice and recommendations.

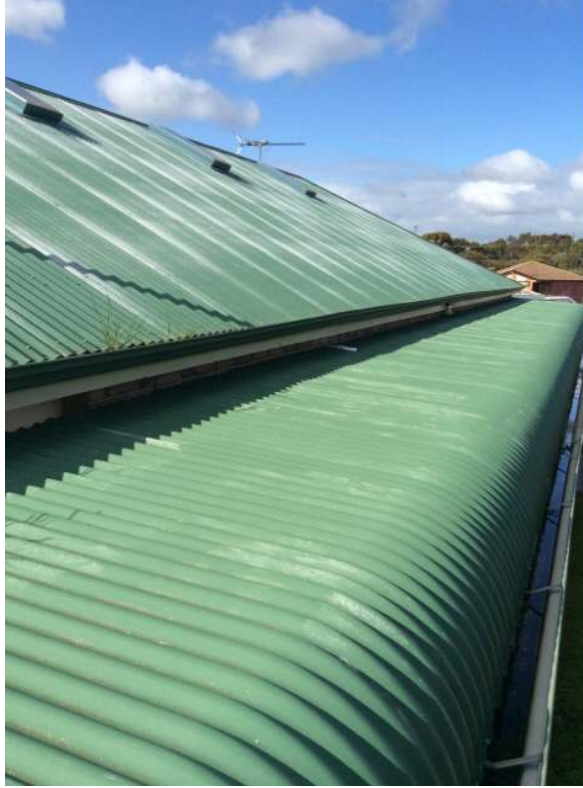
The corrugated sheets are in good structural condition but require some minor maintenance. Painting is recommended.

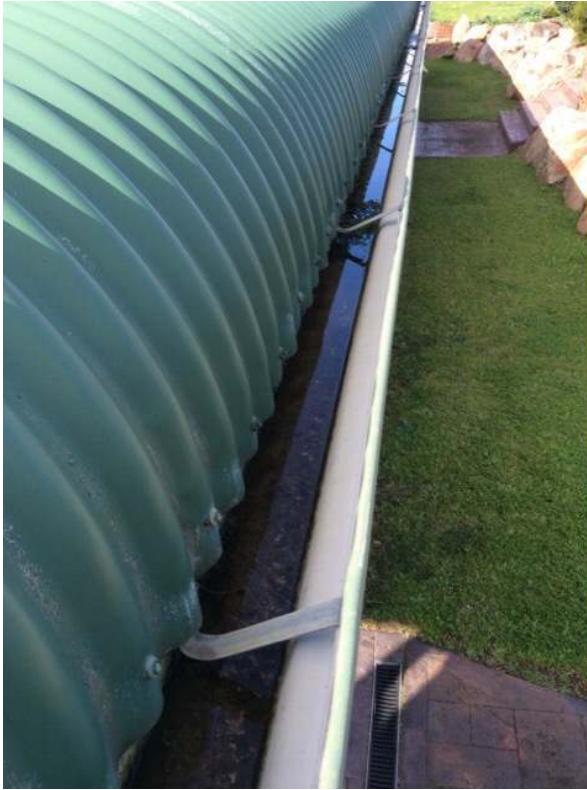
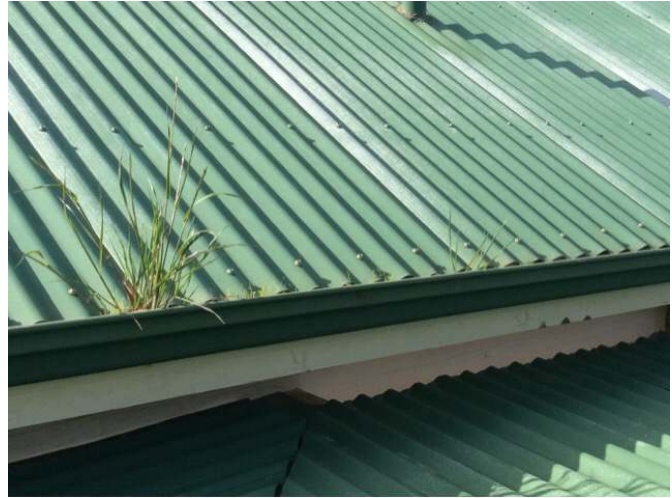
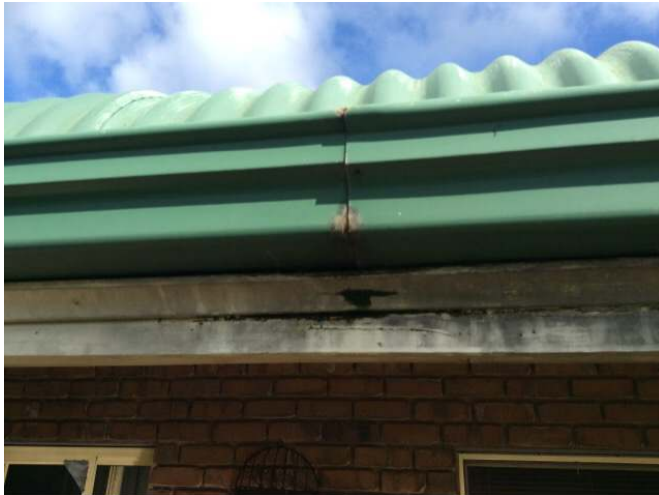
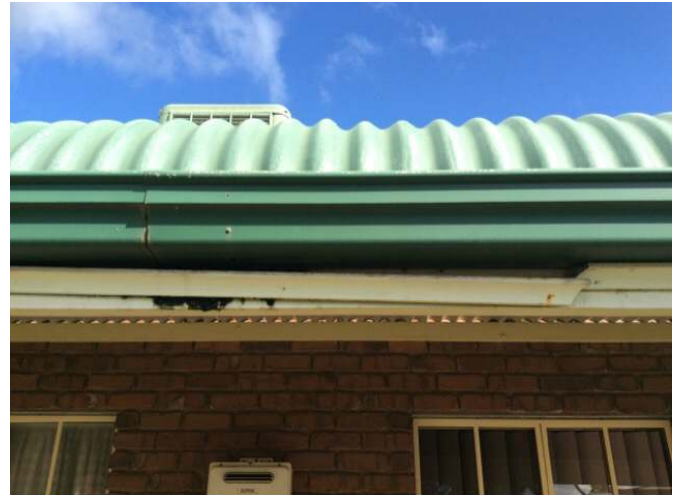
Gutter ponding - This can relate to poor fall, inadequate down pipes, gutter or debris build up. If debris presence has been noted above clean same out and re-assess for any ponding. If clean guttering is ponding it can be a blocked down pipe or the guttering fall is inadequate. Recommendations: A qualified plumber should be engaged for advice and recommendations.

The gutter fall appears inadequate in areas - Recommendations: A qualified plumber should be engaged for advice and recommendations.
