# Inspection Report

**One Stop Inspections**

Report/Agreement # OSI78

This report Complies with Australian Building Standards AS 4349.1-2007. Inspection of Buildings Part 1: Pre- Purchase Inspections-Residential Buildings- Appendix "C and if applicable with AS 4349.3 (Visual Timber Pest Inspection Report)

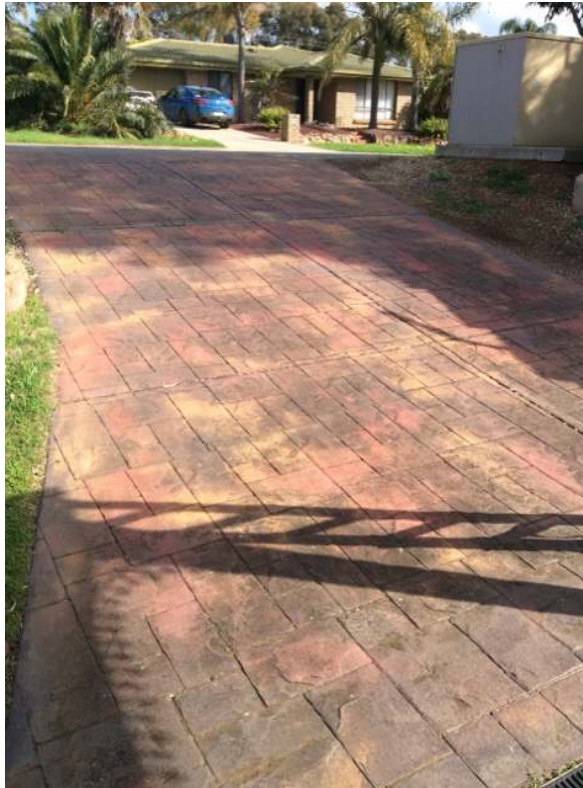
The driveway is concrete.

On visual inspection, the general condition of the driveway is in a reasonable condition.

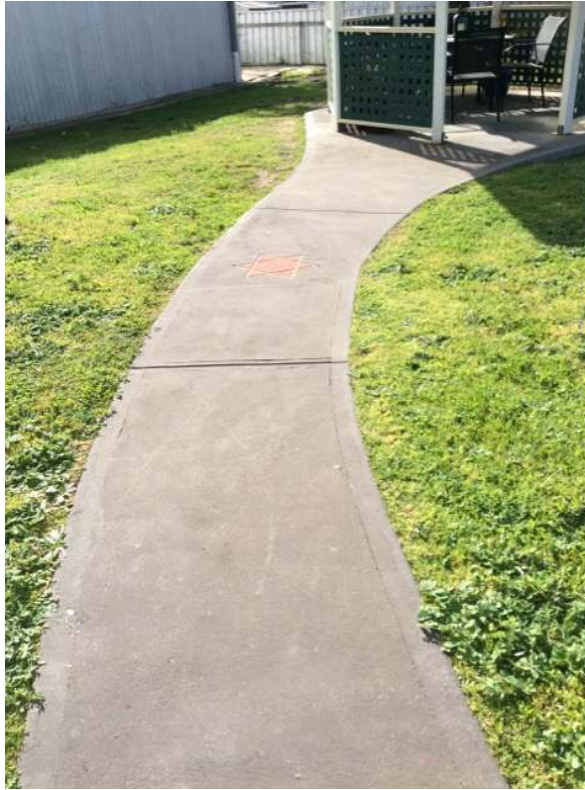
The paths around the home are in reasonable condition for the age of this dwelling with no major defects visible.

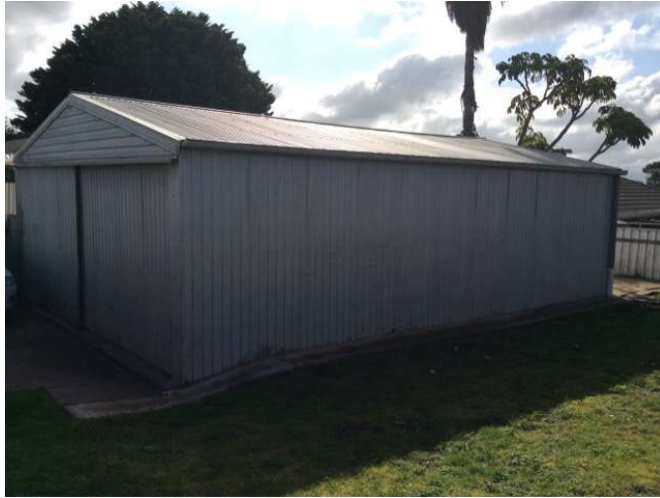
The shed is in fair usable condition.

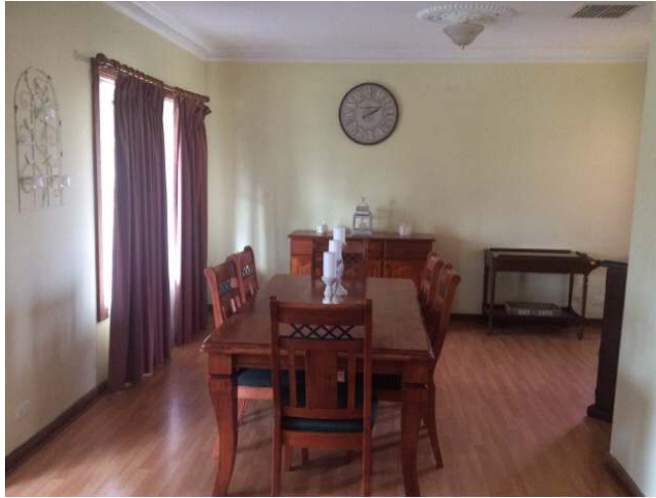
Of areas visible, there was no visible evidence of any major structural defects, safety hazards or major defects likely to cause further deterioration of the dwelling.

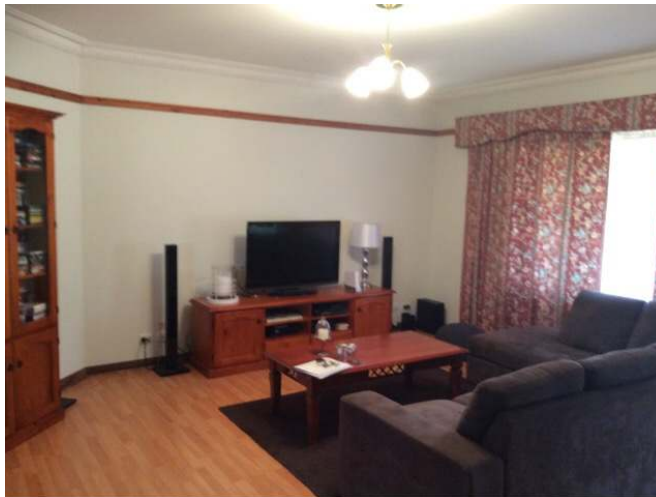
Of areas visible, there was no visible evidence of any major structural defects, safety hazards or major defects likely to cause further deterioration of the dwelling.

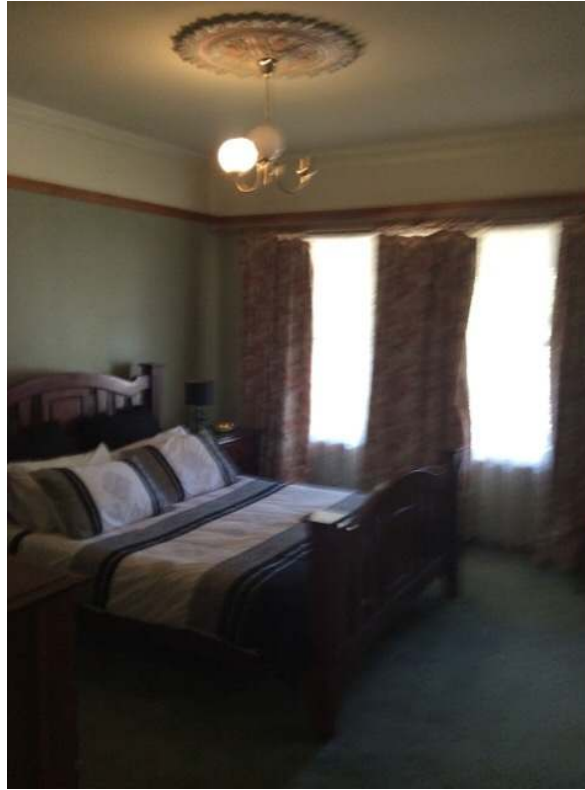
Of the visible areas, the general condition of this bedroom is acceptable or in reasonable condition for the age of dwelling.

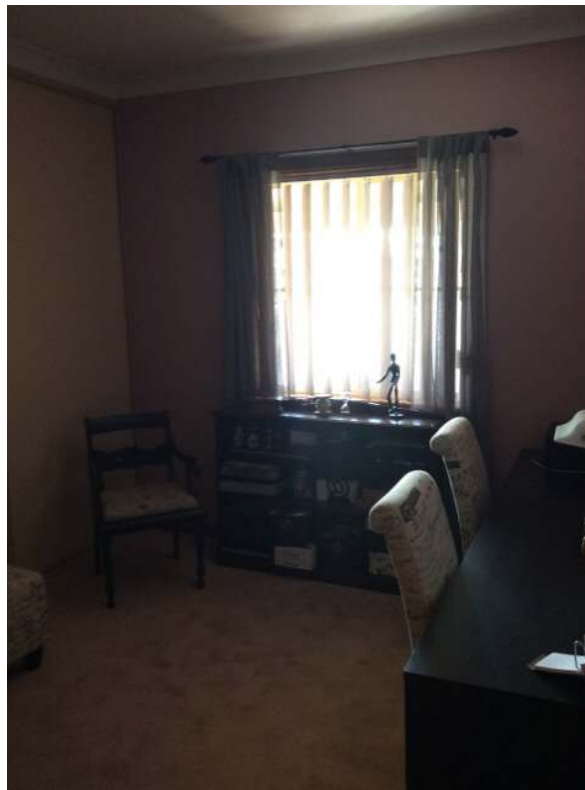
Of the visible areas, the general condition of this bedroom is acceptable or in reasonable condition for the age of dwelling.

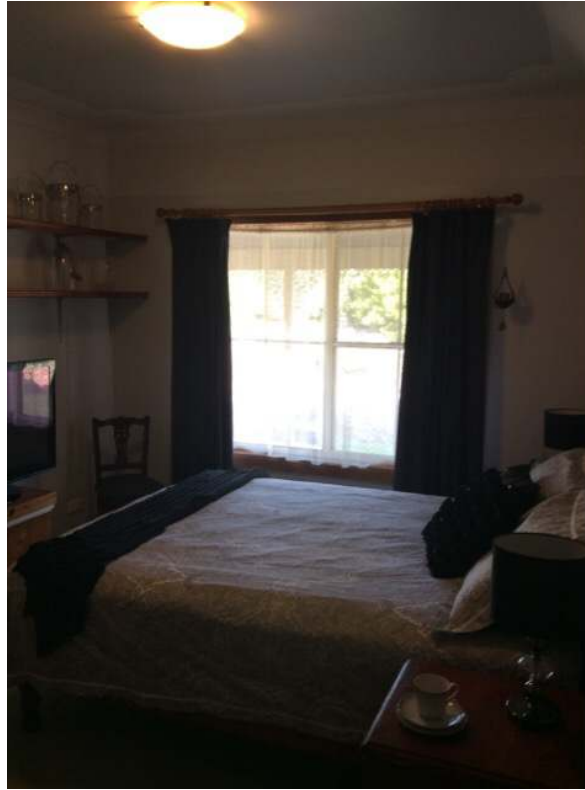
Of the visible areas, the general condition of this bedroom is acceptable or in reasonable condition for the age of dwelling.

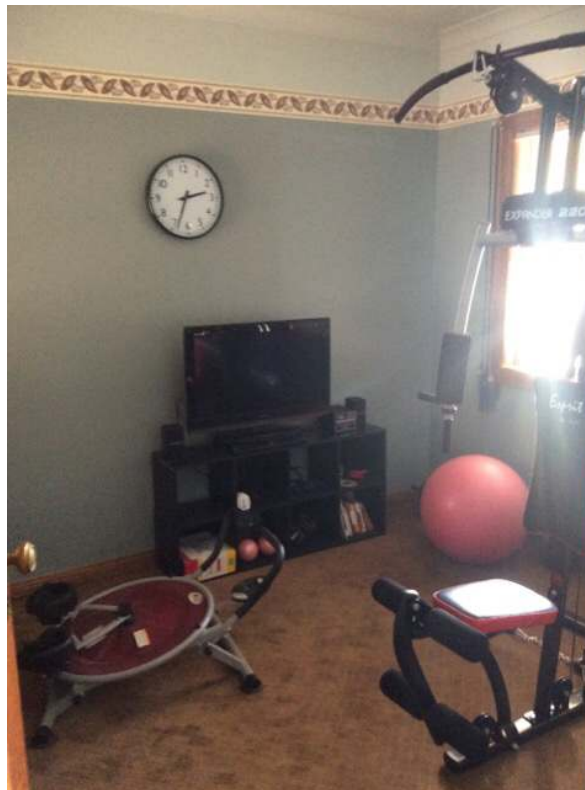
Of the visible areas, the general condition of this bedroom is acceptable or in reasonable condition for the age of dwelling.

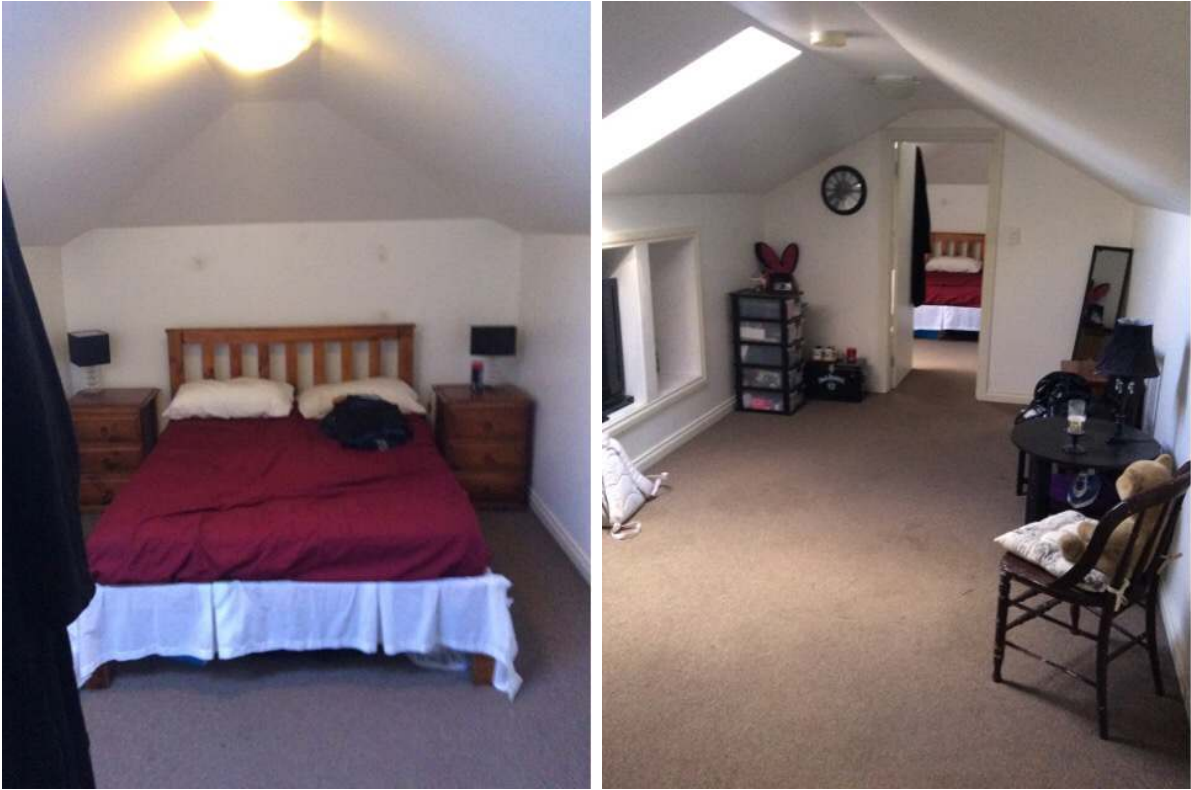
Of the visible areas, the general condition of this bedroom is acceptable or in reasonable condition for the age of dwelling.

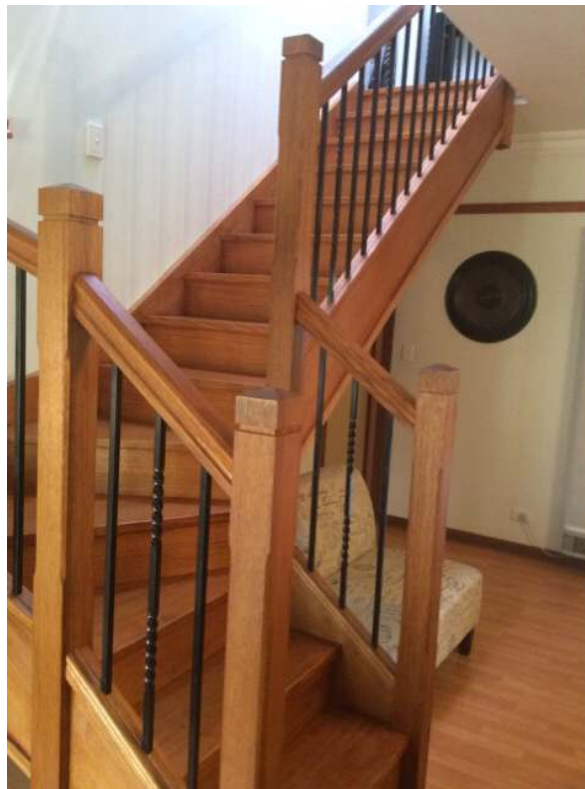
The interior stairs are in a serviceable condition with no notable defects sighted

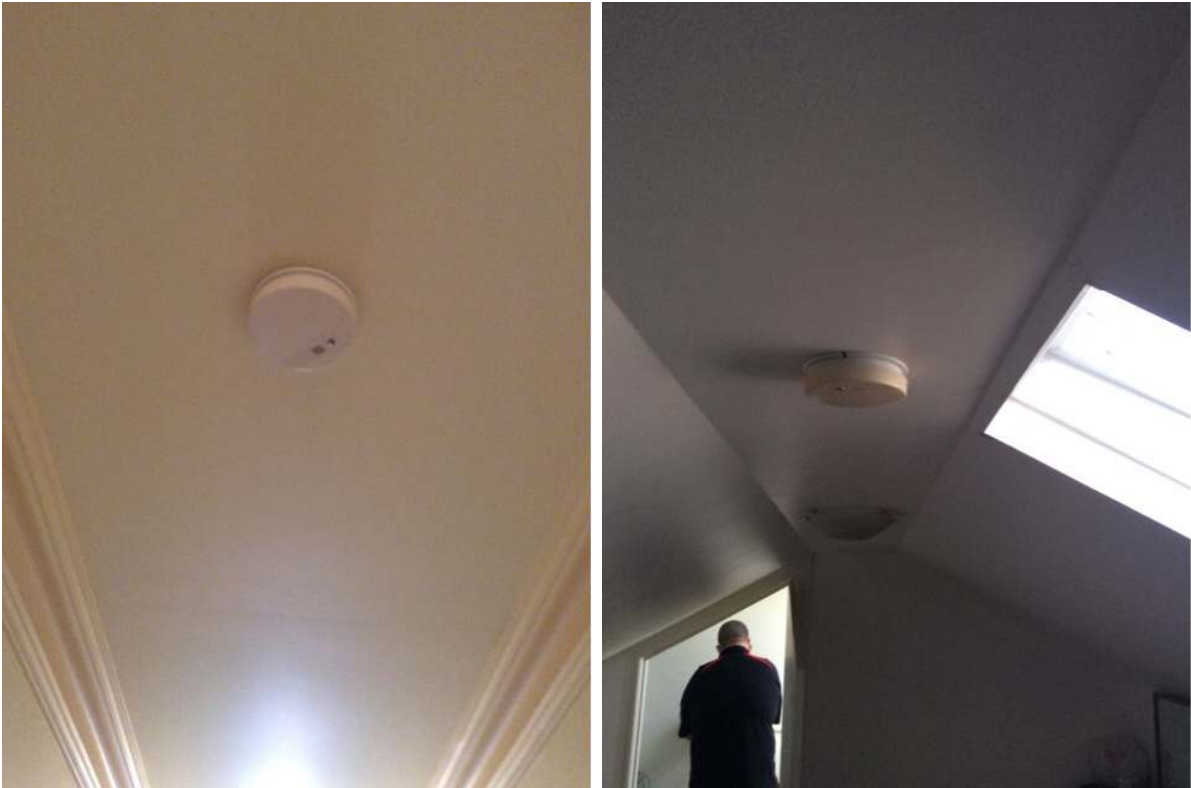
Yes a smoke alarm was noted but not tested.

All dwellings must have at least one working smoke alarm (sometimes mistakenly referred to as “smoke detectors”) installed on each level of their home. This includes owner occupied, rental properties, relocatable homes or any other residential building where people sleep. We strongly recommend you have a least 1 working smoke alarm installed.

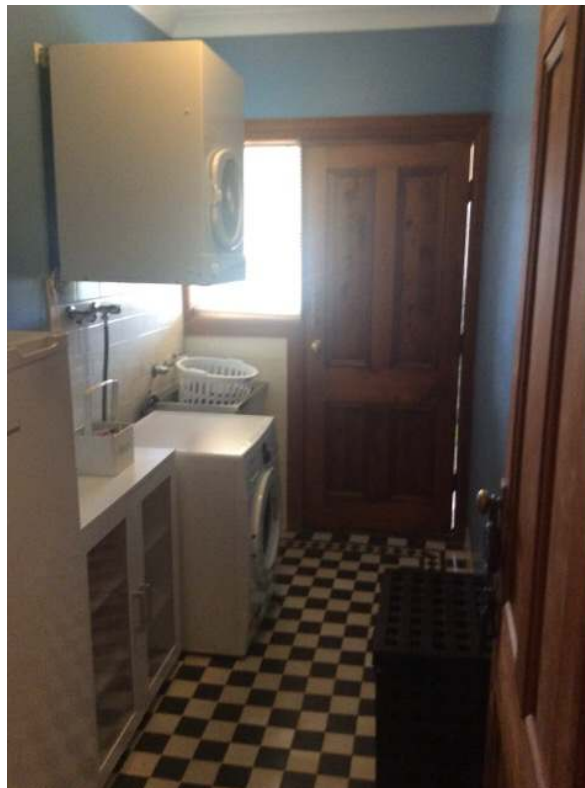
Of the visible areas, the general condition of the laundry is acceptable

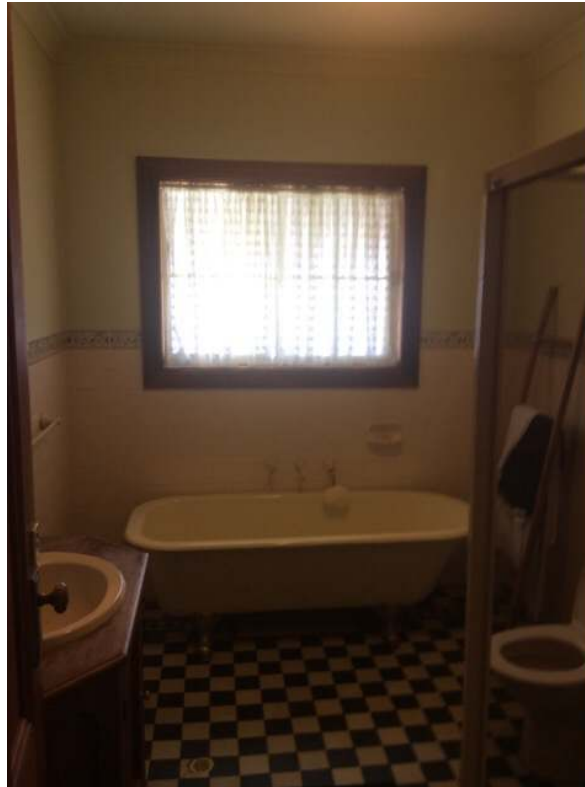
Hall

Of the visible areas, the general condition of this bathroom is acceptable or in reasonable condition for age of dwelling.

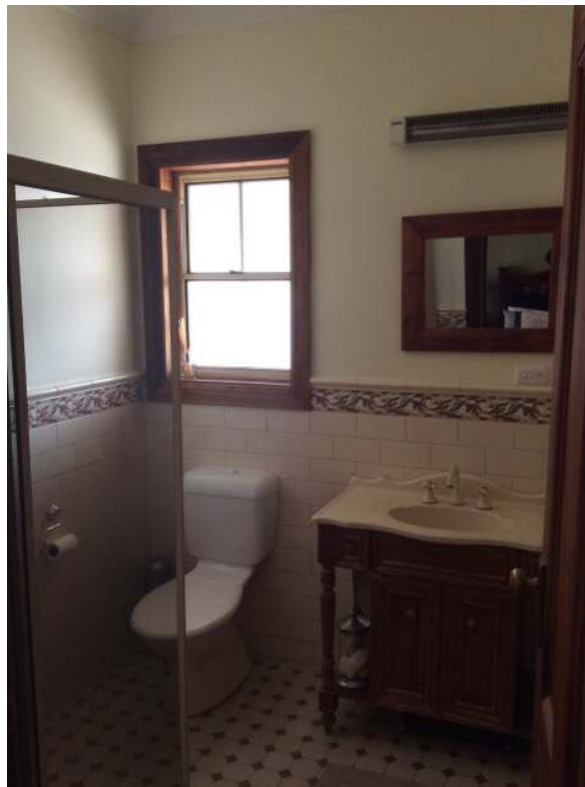
Master bedroom

Of the visible areas, the general condition of this bathroom is acceptable or in reasonable condition for age of dwelling.

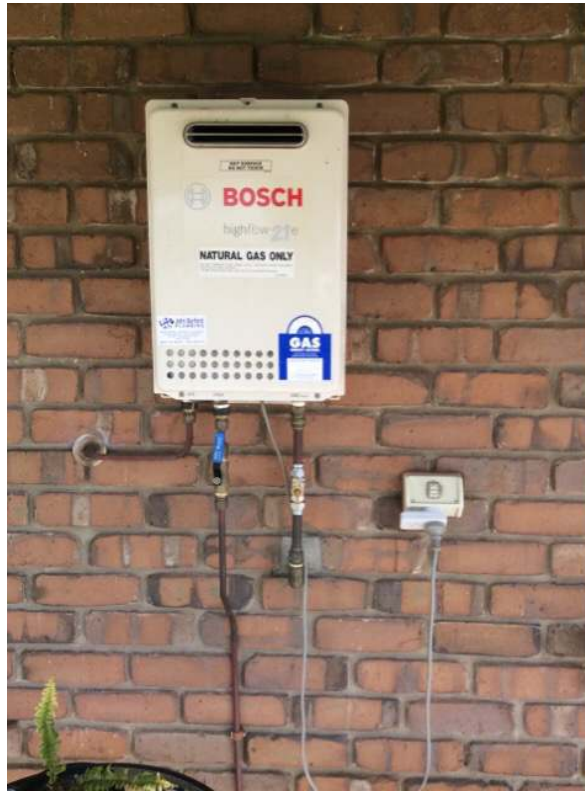
The hot water system appears to be in working condition. No specific tests other than running the hot water from a tap was carried out. No determination has been made as to the suitability or adequacy of the hot water system in relation to capacity or otherwise.

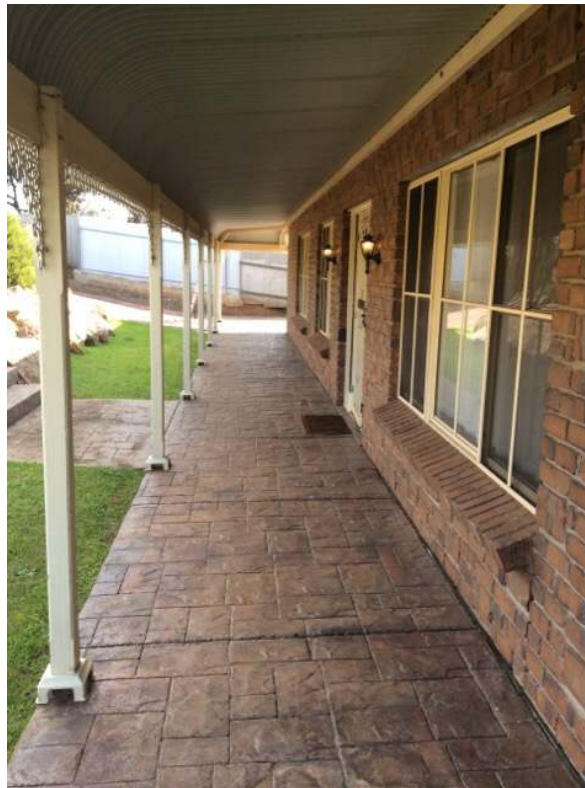
Though we are not structural engineers the veranda/s appear to be in sound condition with no safety issues sighted.
